Historic England

# Historic Fibrous Plaster in the UK

Guidance on its Care and Management

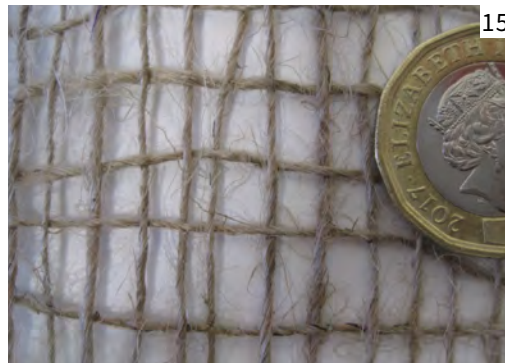
Figure 15: Modern hessian for producing traditional fibrous plaster, with a loose plain-woven fabric of twisted jute or hemp yarns. Plaster of Paris easily penetrates the widely spaced weave.

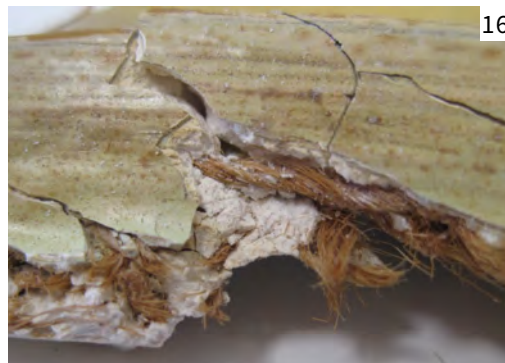
Figure 16: Section through historic fibrous plaster.

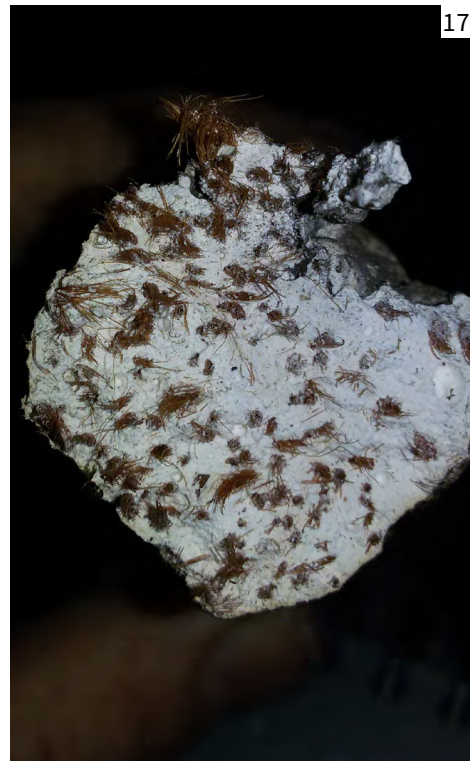
Figure 17: Section through a typical fibrous plaster wad, without wire reinforcement.

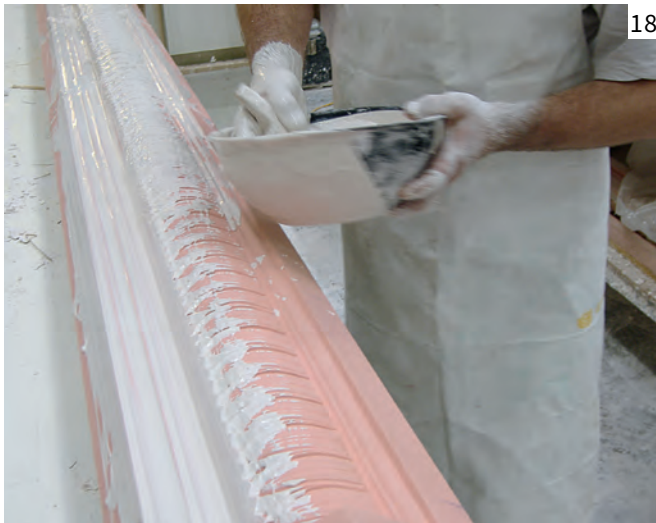
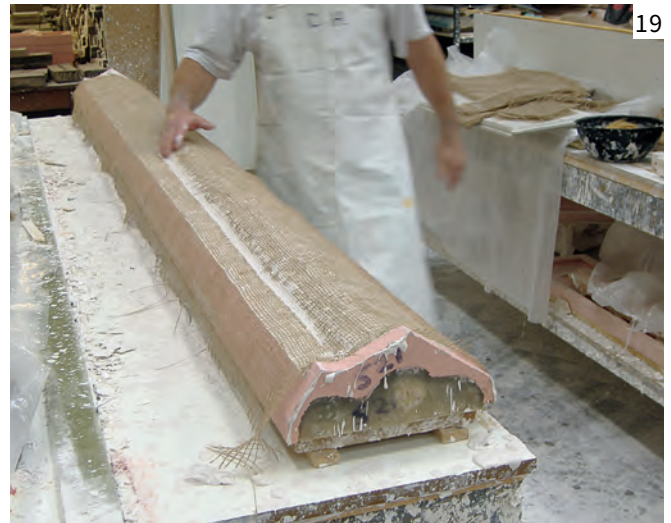
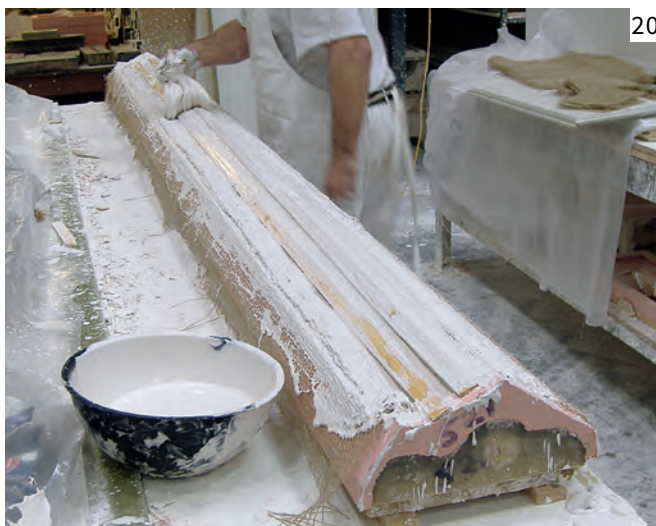
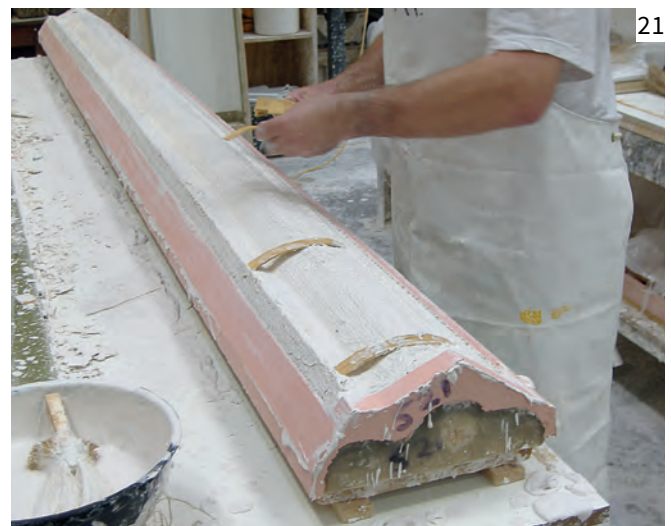
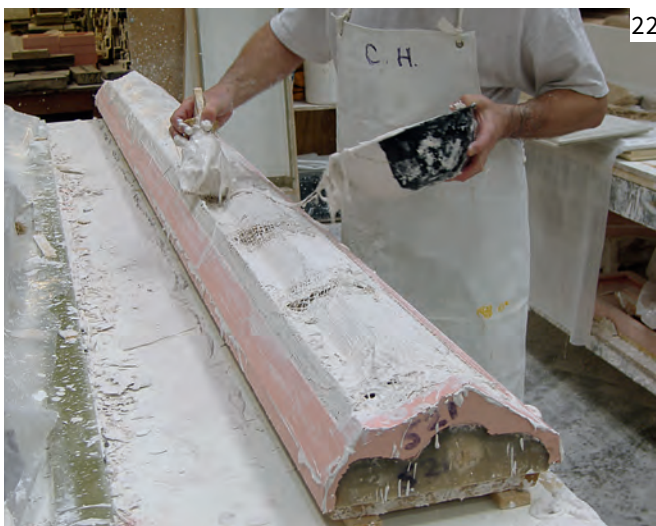
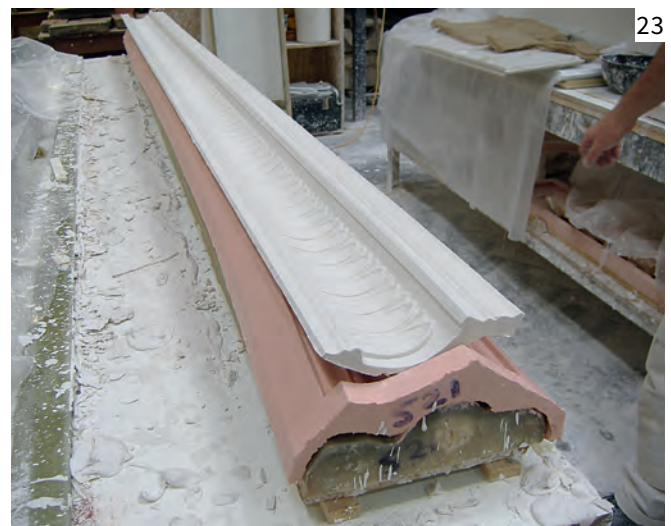
Modern production of traditional fibrous plasterwork moulding, which is slightly different from panel production

18: Brushing on plaster of Paris over a silicon rubber reverse mould.

To make the cast, plaster of Paris is brushed over the mould to form the first coat ('firstings'). This is followed by another coat of plaster ('seconds') gauged with size (animal glue). The first layer of hessian is pressed into the plaster. A second layer of hessian is then laid with more seconds plaster. Timber laths are laid into the seconds plaster as reinforcement and then sealed with more hessian and plaster. The size of the fibrous plaster cast is generally limited to the reach of the plasterer's arm: approximately 2m x 2m for general handling, and safe access to the back of the cast for the installation of fixings.

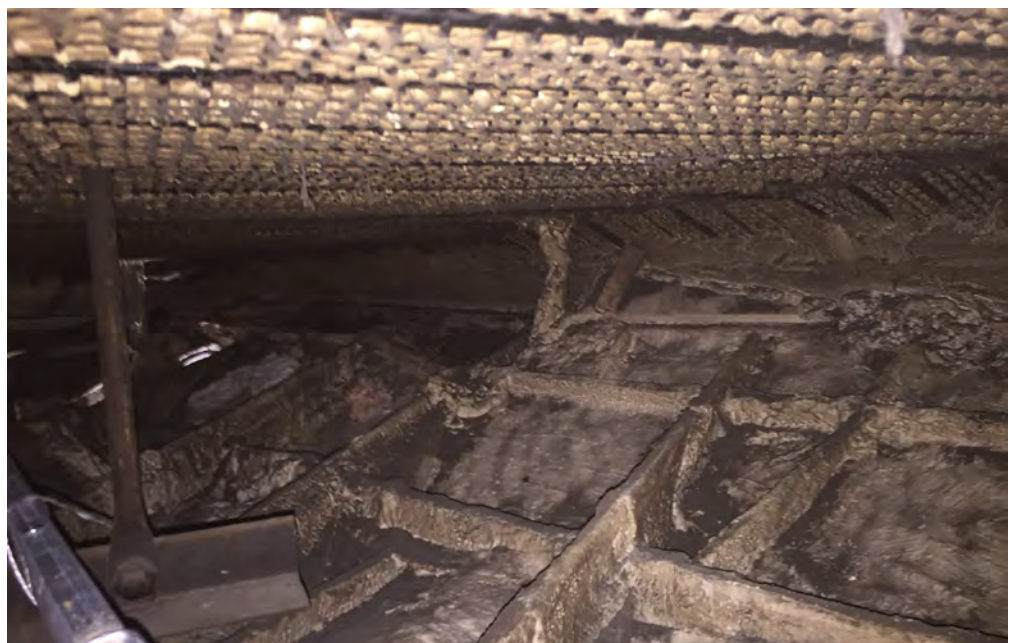
Figure 29: Large area of ceiling installed without sufficient wad connections to the panels. This can be easily detected in an inspection and remedied in subsequent repairs.

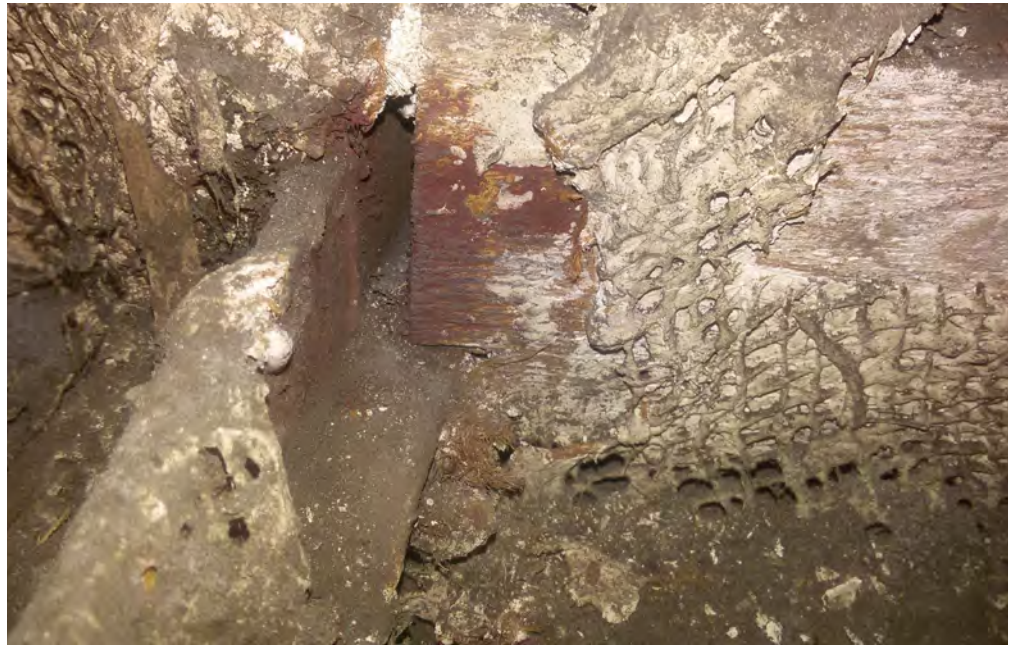
Figure 30: Poor bearing of a timber ceiling joist on a small steel T bar. The hessian has insufficient plaster cover to protect it from degradation. This illustrates how defects can be concentrated.

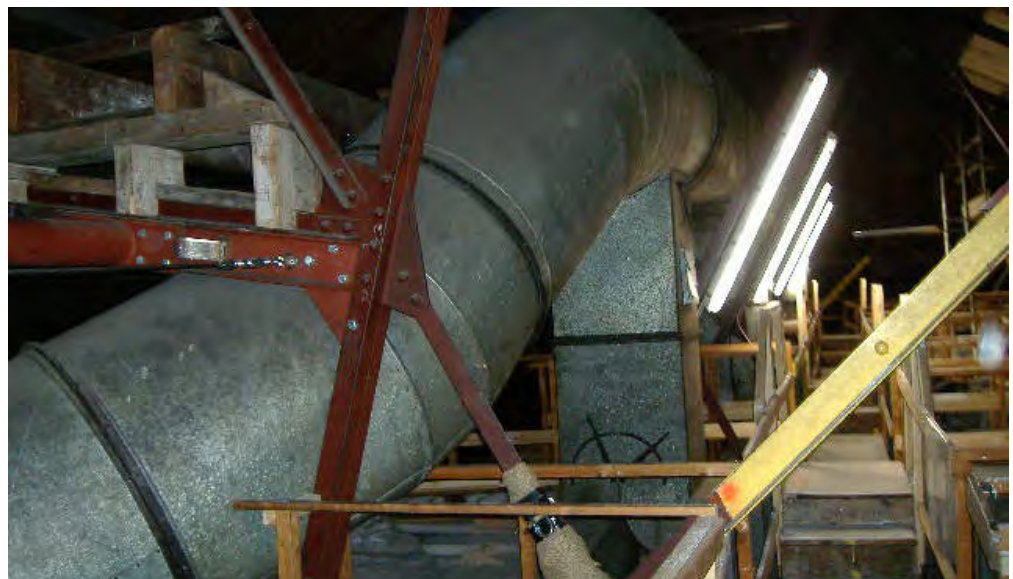
Figure 31: In ceiling voids bulky mechanical plant and boarded walkways (lower right) obscure the fibrous plaster ceiling below and impede its inspection.

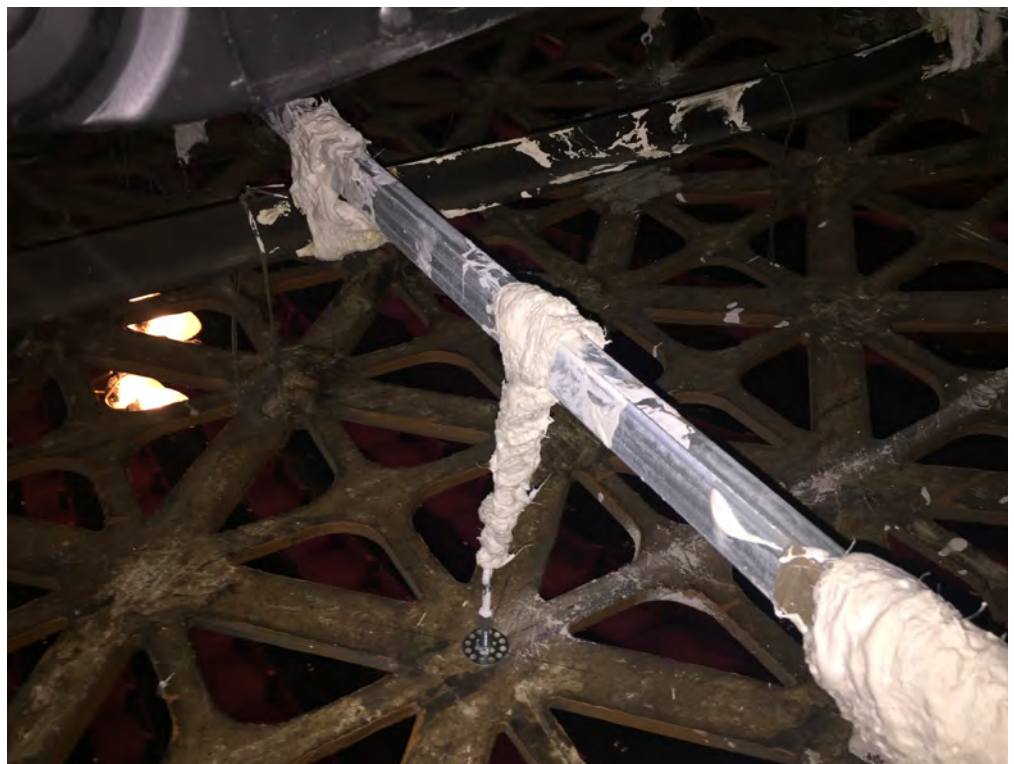
Figure 33: Fibrous plaster fretwork, given supplementary support with a new beam and wire-reinforced wads. This is a standard method of improving the stability of suspended ceilings.
